Re: BUTTE MINE FLOODING SITE CD, CV 02-35 Bu-RFC, 2018 Third Quarter Report

SETTLING DEFENDANTS BUTTE MINE FLOODING OPERABLE UNIT (BMFOU) QUARTERLY REPORT CONSENT DECREE FOR THE BUTTE MINE FLOODING SITE CD, CV 02-35 Bu-RFC REMEDIAL ACTION – IMPLEMENTATION OF THE REMEDY THIRD QUARTER 2018 (JULY 1 – SEPTEMBER 30, 2018)

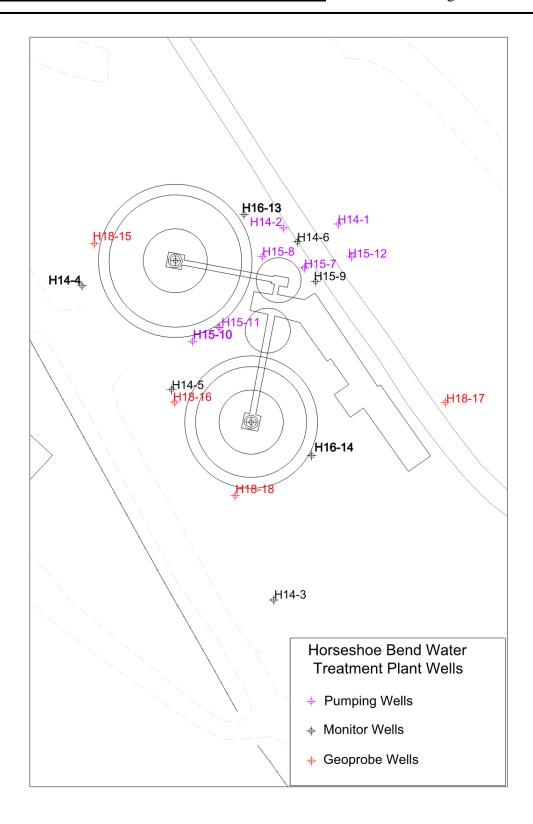
Figure 1. Site map of HsBWTP and surrounding dewatering and monitor wells.

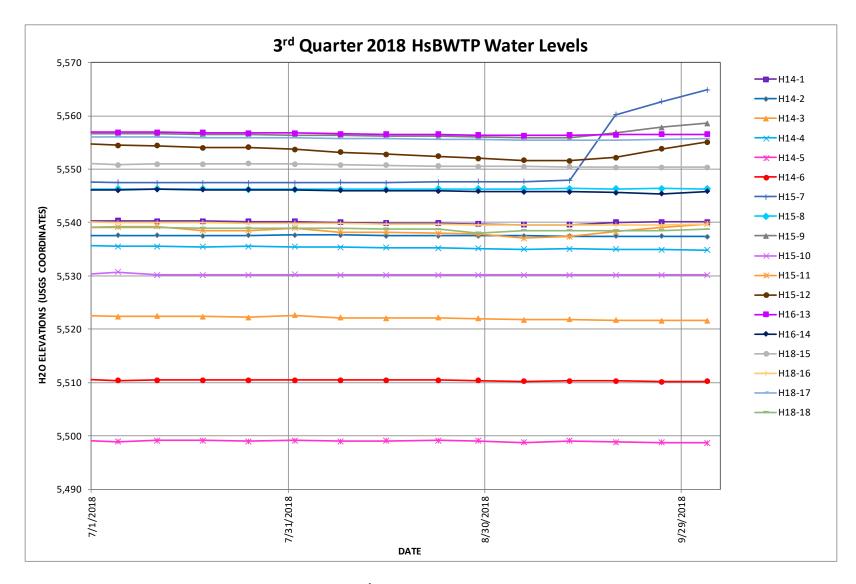
Figure 2. HsBWTP dewatering and monitor well levels for 3rd quarter of 2018.

No new monitor wells were installed during the third quarter. The pumping rate in well H15-7 is slowing down; this will be monitored to determine if the well should be developed and the pump and motor replaced. The Static Water Level (SWL) and Pumping Water Level (PWL) elevations of all wells can be seen in Table 2. A graphical plot of the elevations can be seen in Figure 2.

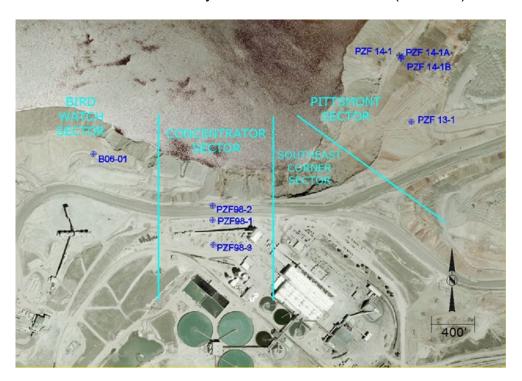
Figure 1. TDR Well locations.

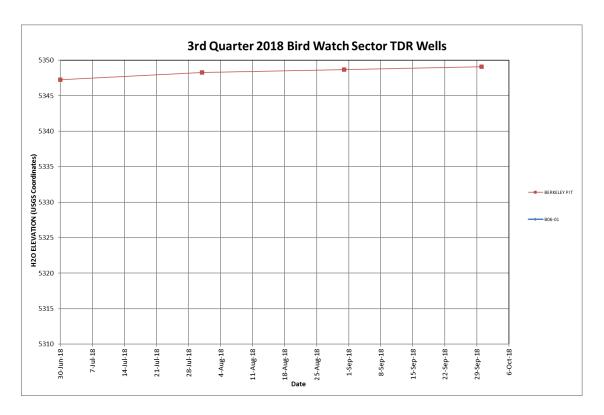
Figure 2. Hydrographs Bird Watch Sector.

Water levels are tracked in all sectors. Hydrographs detailing the piezometric surface in each sector are provided in Figures 2 through 6. There were no unexpected water fluctuations of note during the quarter. Figure 5 shows the piezometric surface in PZF15-2 elevated in late August due to mechanical problems with the pump. Piezometric surface returned to its previous elevations in the well as soon as pumping resumed.

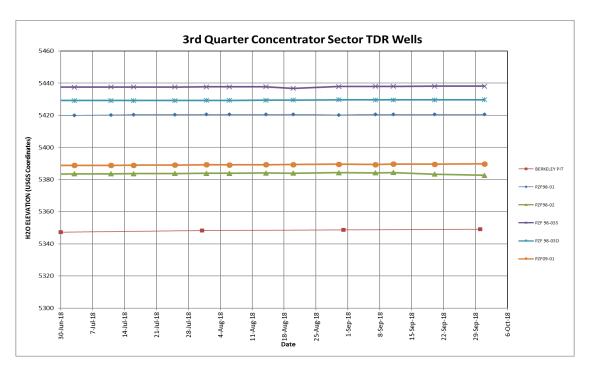
Figure 3. Hydrographs Concentrator Sector.

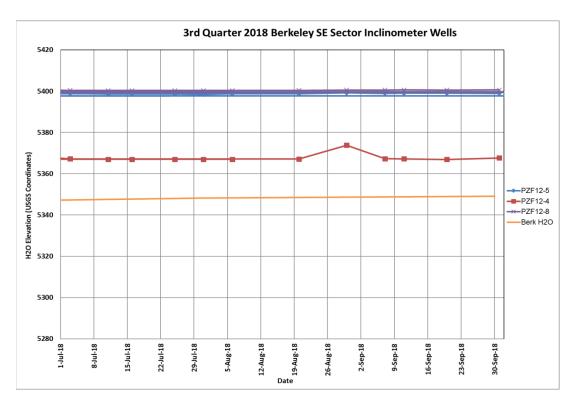
Figure 4. Hydrographs Southeast Sector inclinometer wells.

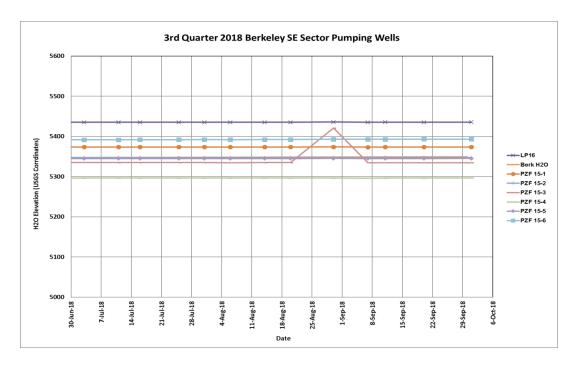
Figure 5. Hydrographs Southeast Sector pumping wells

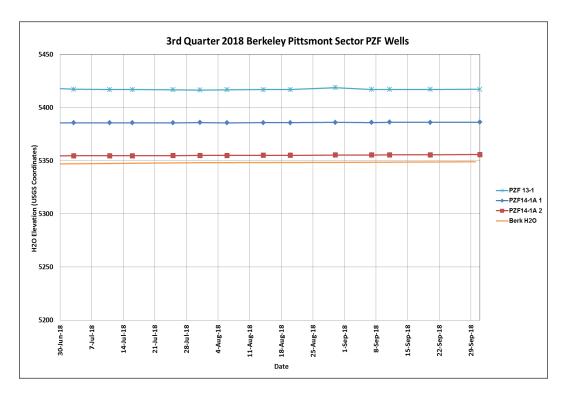
Figure 6. Hydrographs Pittsmont Sector.
